# Forest Harvest Best Management Practices in Maryland and Delaware: Use and Effectiveness: 2016 Results

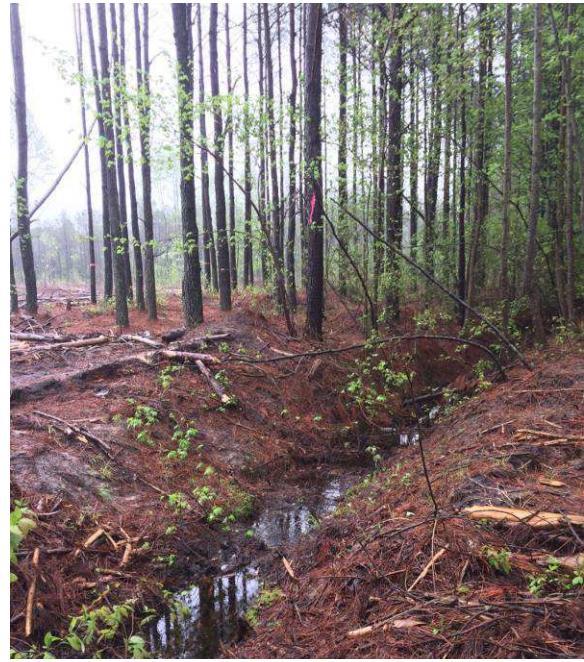
Top: re-vegetated haul road, Vision Forestry. Bottom: Waterway buffer and removed crossing structure, Maryland Forest Service.

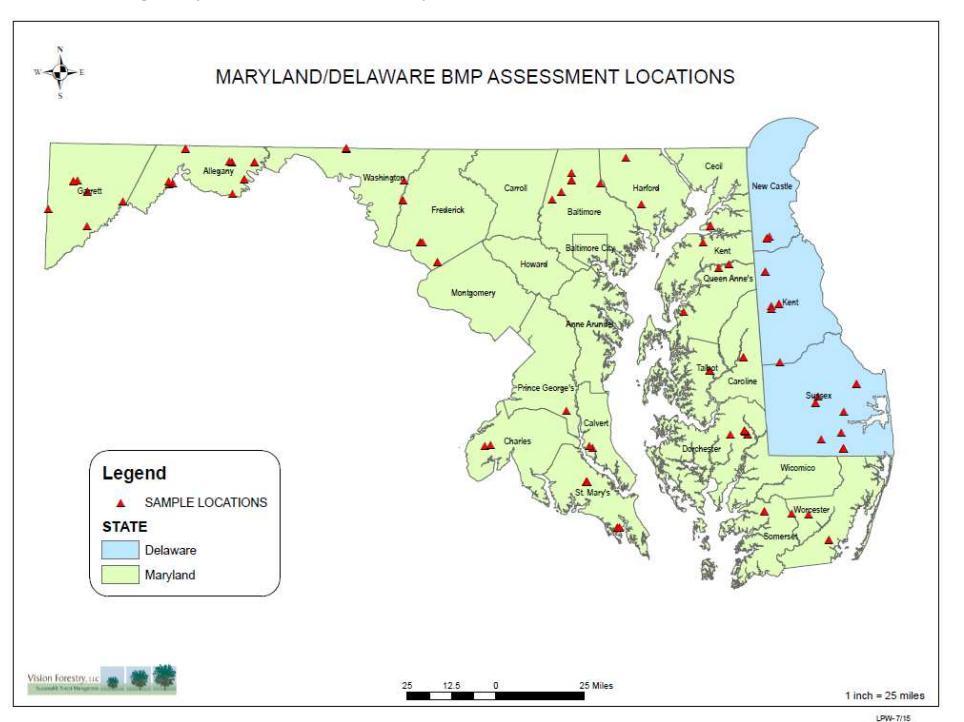
Figure 1: Forest Harvest best management practices evaluation locations in Maryland and Delaware a

A forestry contractor visited 72 sites throughout Maryland and Delaware. (Figure 1.) Eleven sites were visited for quality assurance by state forestry staff, with resulting 94 percent consistency in sediment evaluation results.

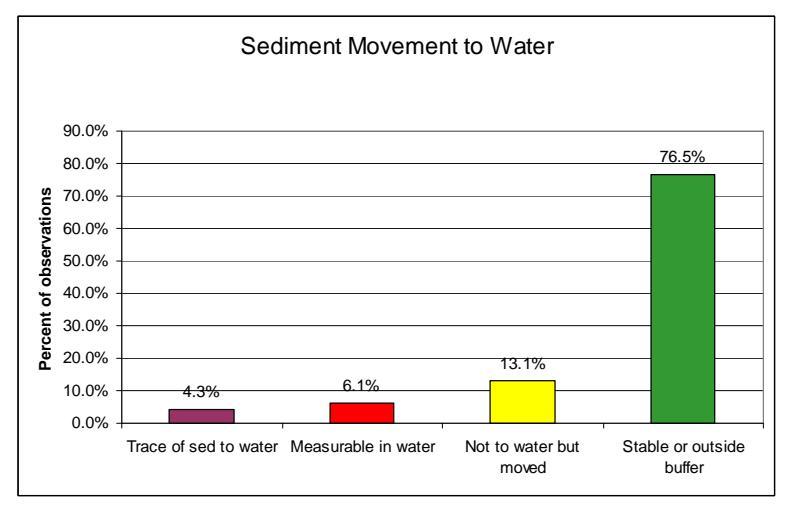
Figure 2: Evidence of sediment movement on harvests with crossings.

On sites with water crossings, **90 percent** avoided delivering sediment to waterways, while 6 percent delivered measurable amounts of sediment at crossings or approaches (Figure 2).

The average volume of delivered sediment, estimated from rill and gully dimensions, was 14 cubic feet. Factoring in all sites, including those without water crossings, average sediment delivery per harvest site was **less than 1 cubic foot**. Sites with crossings averaged 4 cubic feet per site. The most common location for sediment impacts was at the crossing itself, where there are the fewest opportunities to divert or filter out

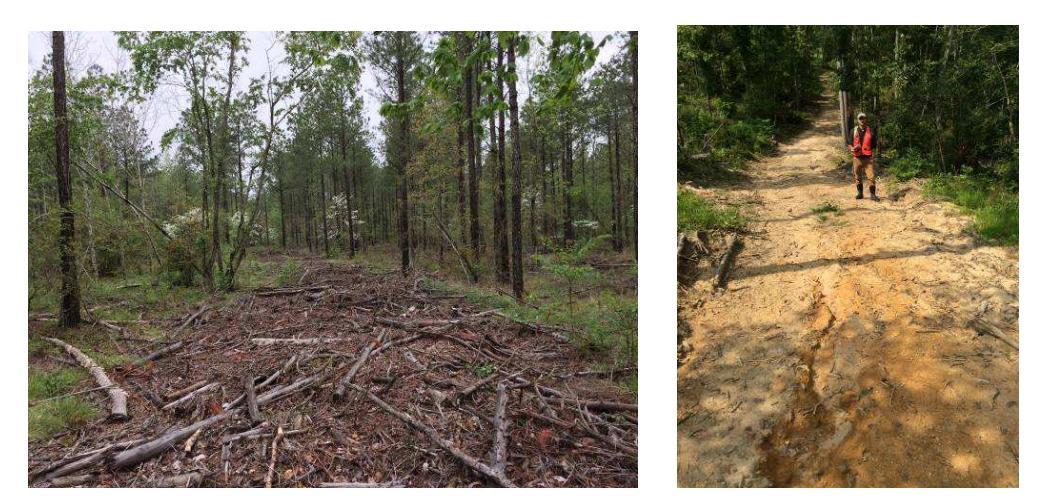
Left: Skid trail with tops used to protect soil, Maryland Forest Service. Right: Skid trail without BMPs with rill erosion, Vision Forestry.

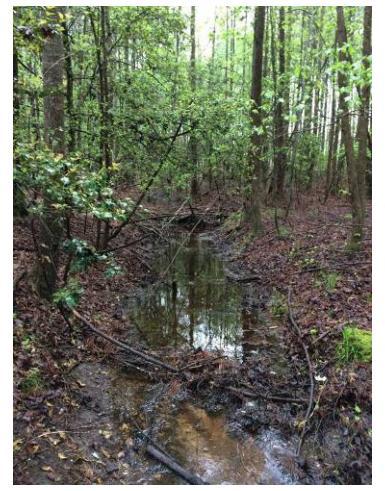
Buffered coastal plain waterway, Marvland Forest Service.

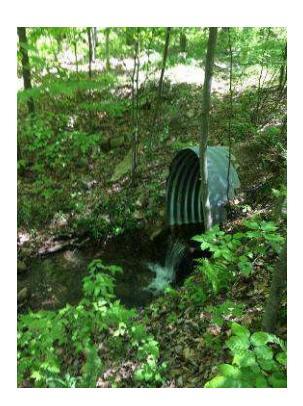
Most sites allowed movement of fish and other aquatic dwellers such as benthic macroinvertebrates (stream insects). On 8 percent of sites, crossings structures were perched or lacked natural substrate that would aid passage. More than half of stream crossing structures were removed after harvest to aid fish passage. Only 20 percent of remaining structures, usually culvert pipes, constricted the stream cross-section.

Perched culvert, Maryland Forest Service.
